UNITED STATES NAVY - CANADIAN FORCES
SOLID STATE FLIGHT DATA RECORDER/CRASH POSITION LOCATOR
EXPERIMENT ON THE B-720 CONTROLLED IMPACT DEMONSTRATION

D. M. WATTERS
Naval Air Test Center
Patuxent River, Maryland 20670-5304

NASA/FAA Government/Industry CID Workshop
NASA Langley Research Center
April 10, 1985

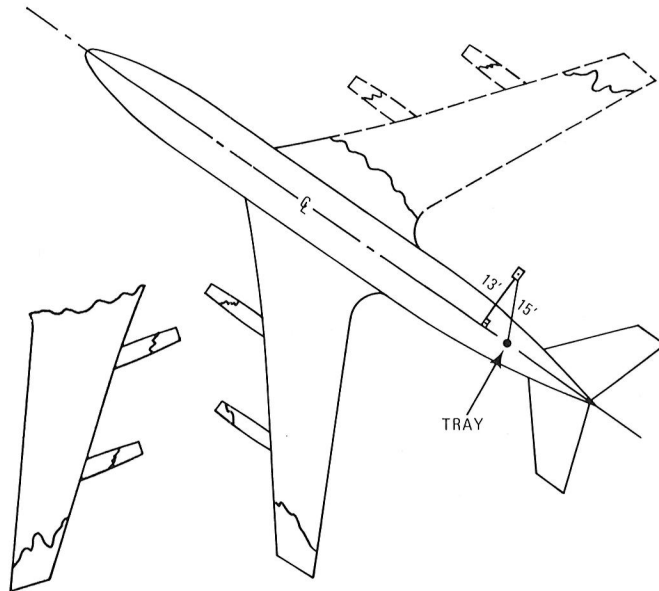
Figure 7
RBA-46 LOCATION RELATIVE TO B-720 AFTER CID

Navy personnel access to the crash site was allowed on the morning of December 2, 1984. The CPL RBA-46 was found resting top side up, 15 feet forward and 13 feet perpendicular from the tray location on the starboard side of the aircraft. Figure 7 shows the final location of the CPL RBA-46. An immediate inspection indicated the airfoil suffered moderate fire damage with paint peeling but not intumescing. The visual marker strobe lamp housings were intact but extensively burned such that it was impossible to see if the lamps had survived. The airfoil suffered minor structural damage, with assorted dents, etc. The SSFDR cavity was intact with the top surface of the recorder being blackened by fire. Figures 8 and 9 show the CPL RBA-46 as found at the B-720 crash site.

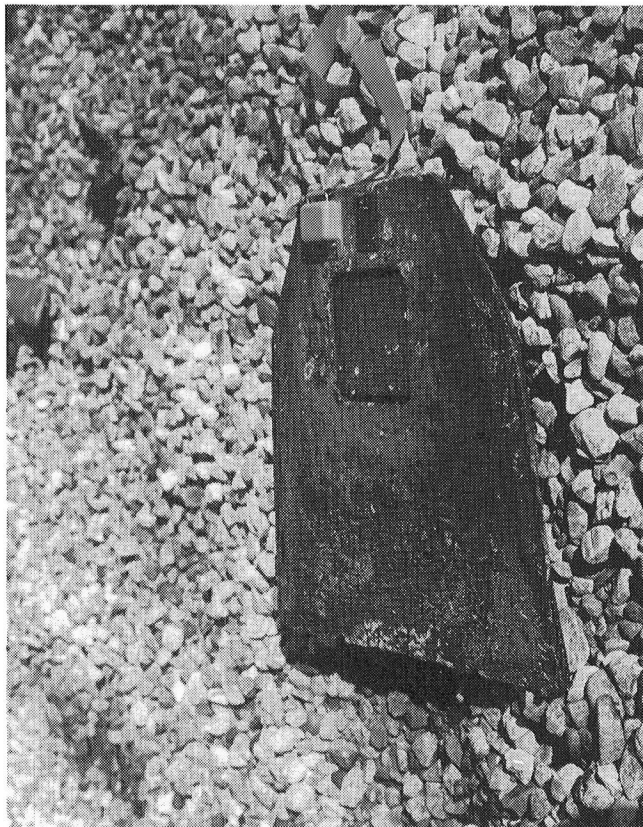
Figure 8
RBA-46 EXTERNAL SURFACE AFTER B-720 CID

The extended plunger on the ARU-21 release unit indicated that the pyrotechnic deployment system operated. The radio beacon base (tray) suffered some heat and fire damage, and was charred and blackened by smoke.

Initial inspection showed charring on both sides of the airfoil. Structurally the airfoil was intact with various dents, etc. on its surface. The airfoil was soaked in fluids which were a combination of antimisting kerosene (AMK) jet fuel and fire fighting foam. Henceforth this fluid will be referred to as "crash fluid".

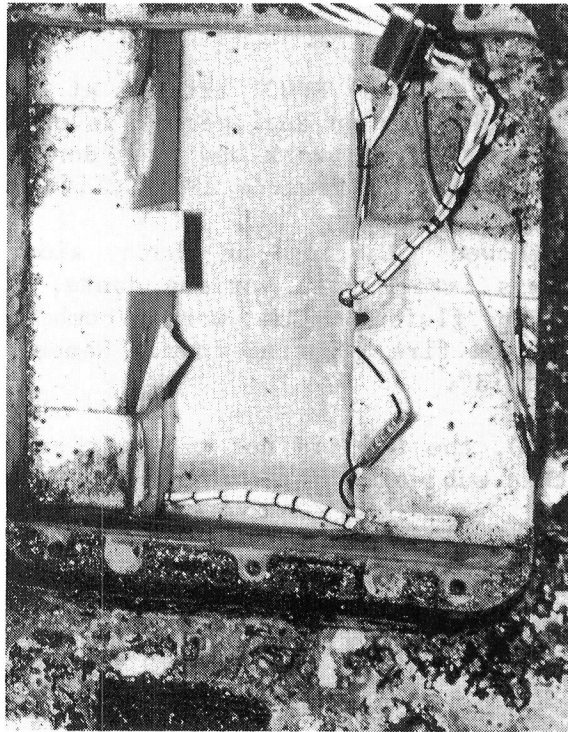
Figure 10
RBA-46 PAYLOAD CAVITY WITH SSFDR REMOVED

The SSFDR was removed from the RBA-46 airfoil to provide access to the CPL payload cavity. Each assembly was then tested to determine its state. Figure 10 shows the payload cavity before disassembly.

The SSFDR case was wet with crash fluids. All the assemblies in the cavity had their encapsulating foam soaked with crash fluids. The fluids had seeped in around the SSFDR because there was no seal installed. Sediment due to corrosion was found on the SSFDR connector as well as on the surface of the foam and on the wiring harness. These consisted primarily of green copper deposits. Figures 11 and 12 show the SSFDR before disassembly.

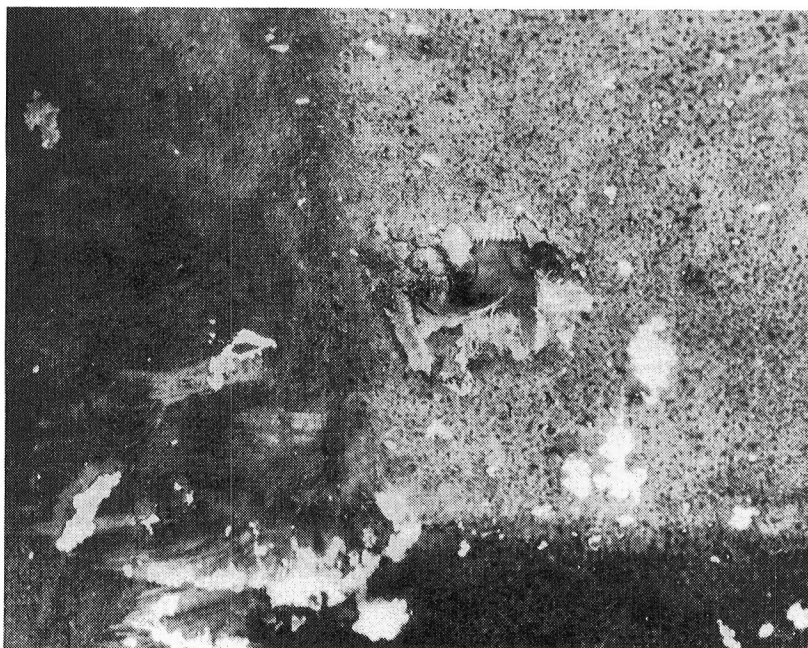
Figure 14
PUNCTURE IN RBA-46 AIRFOIL EXTERNAL SURFACE
